IMPORTANT SAFETY NOTICE – IMMEDIATE ACTION REQUIRED

Subject: Varian TV 801 Turbo Pumps on the API 4000[™], 4000 QTRAP[®], and API 5000[™] Mass Spectrometers

Date: 2017/03/13

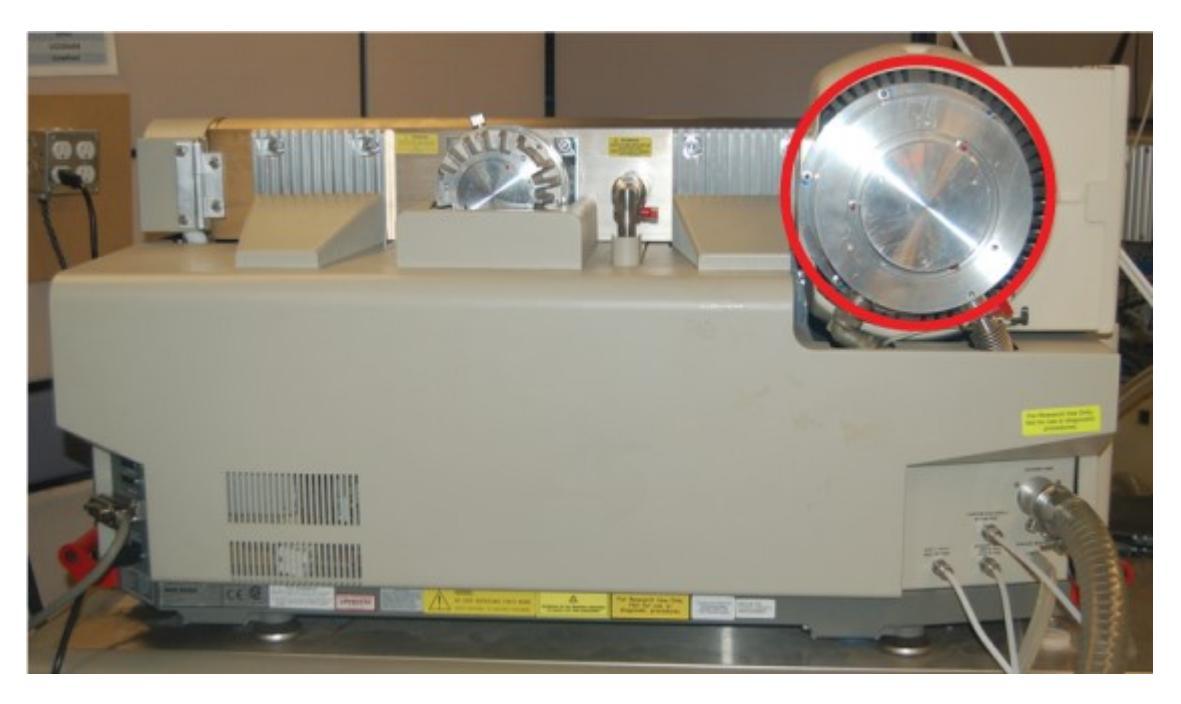
1. Locate the turbo pump. The turbo pump is on the back of the instrument, on the top right, as shown in Figure 1.

Figure 1: Turbo Pump (Shown Inside the Red Circle)

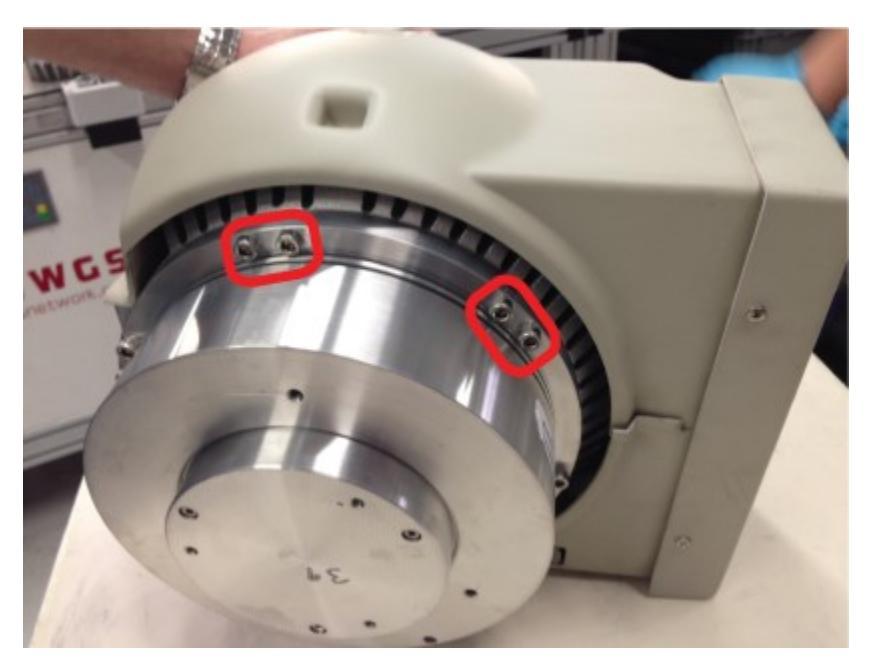
2. Inspect the pump to determine the number of securing bolts. Refer to Figure 2 and Figure 3.

If the pump has double bolts, then it is NOT a TV 801 pump. No further action is required.

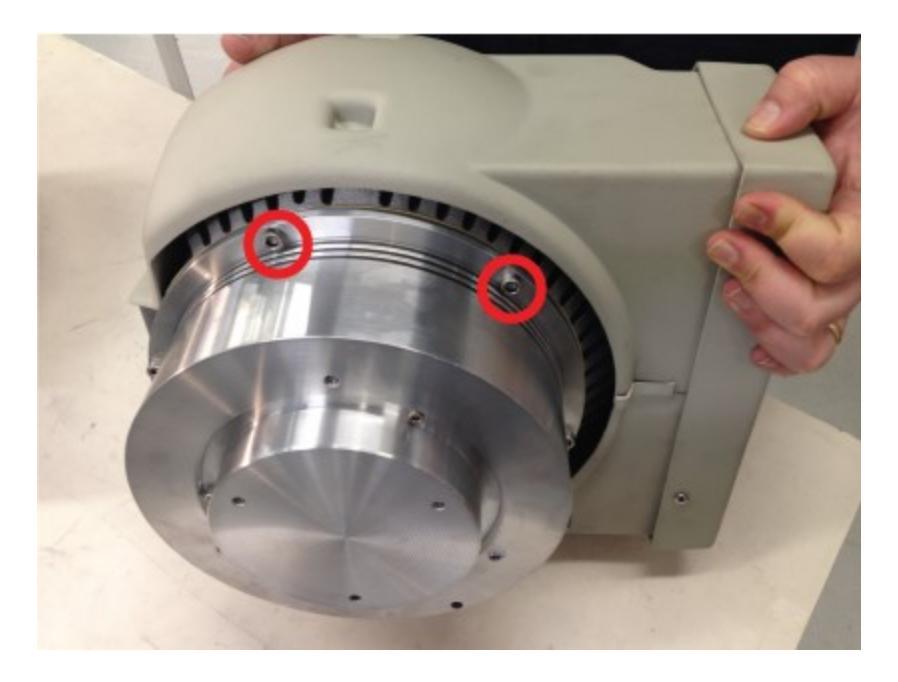
If the pump has single bolts, then it is a TV 801 pump. Immediate action is required.

Figure 3: TV 801 Pump with Single Bolts (Action Required - Shut Down the System Immediately by following the "<u>How to Shut Down the System</u>" section below.)

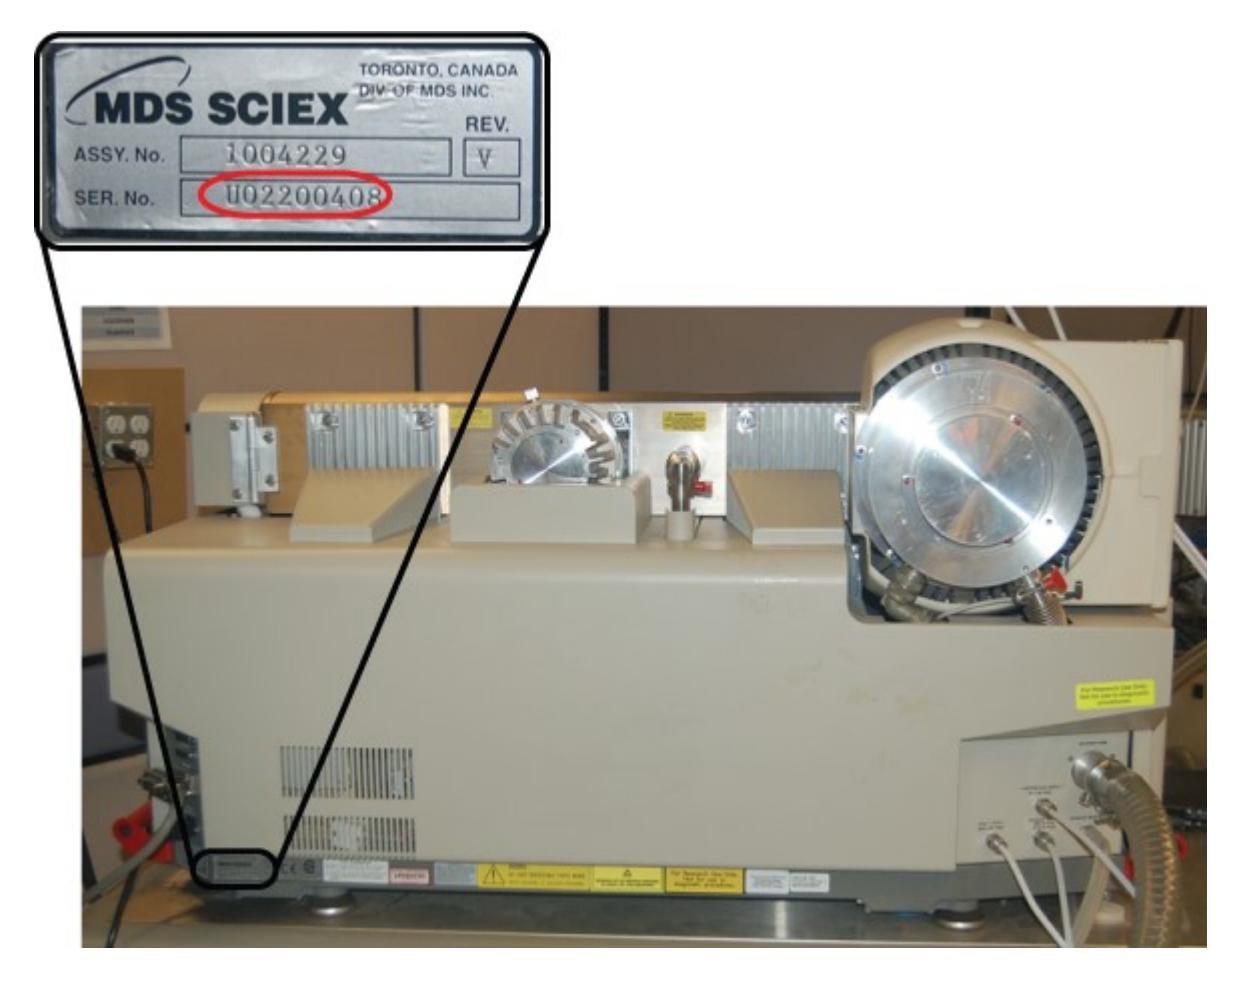
Figure 4: Mass Spectrometer Serial Number Location

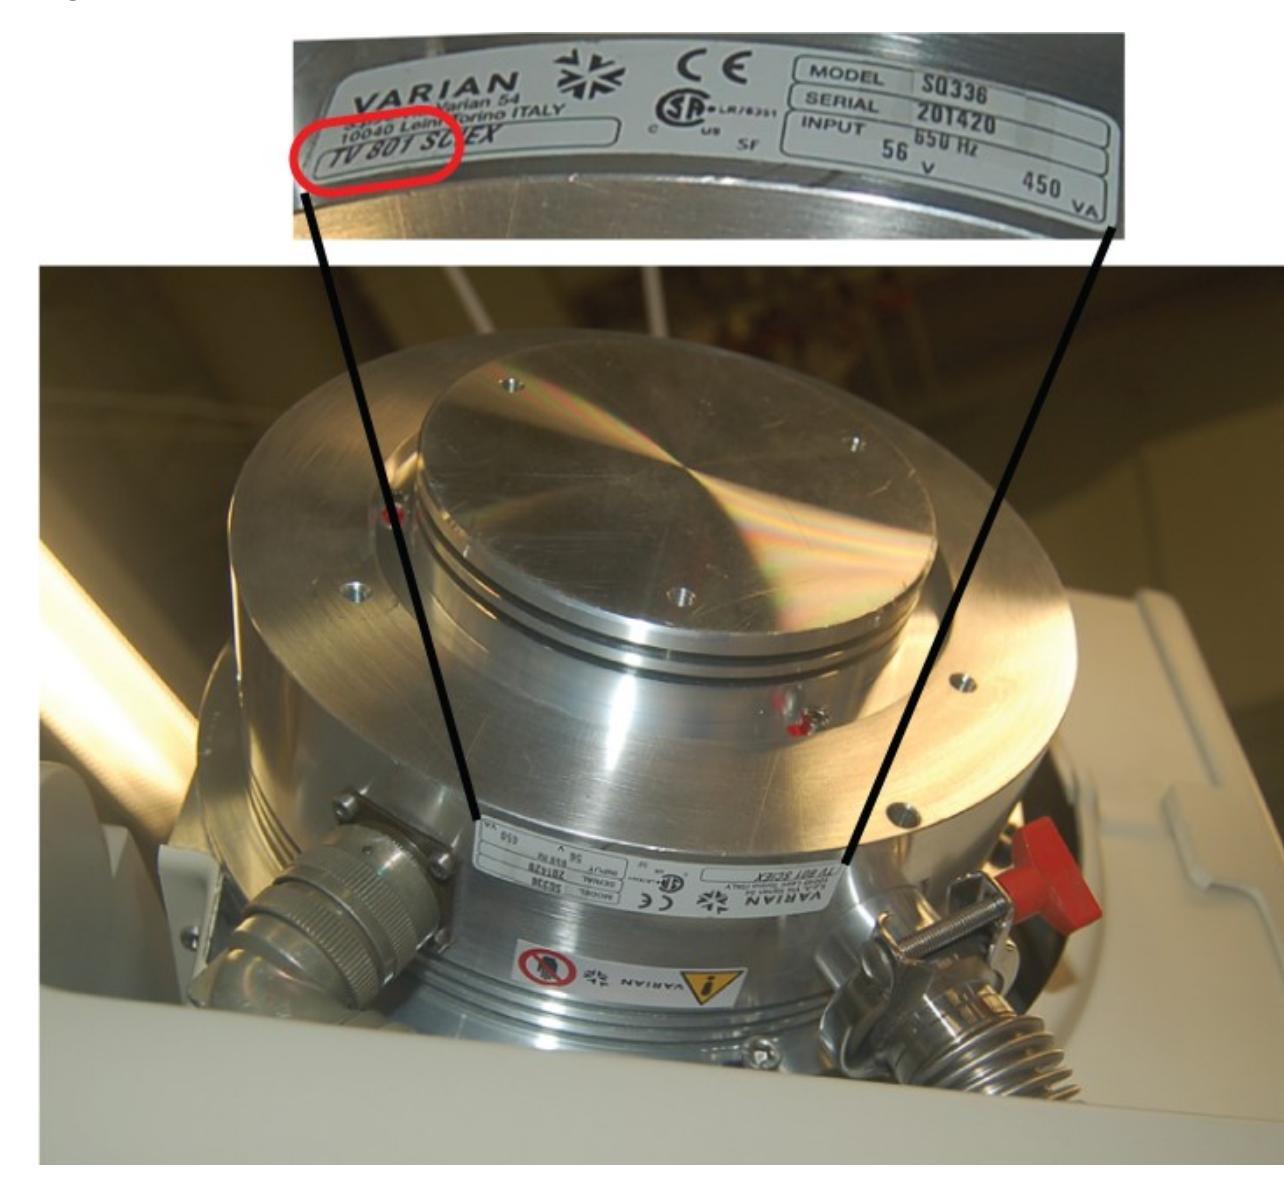
Figure 5: Turbo Pump Model & Serial Number Location
