LIQUID NITROGEN DEWAR VALVE FAILURE

What Happened?

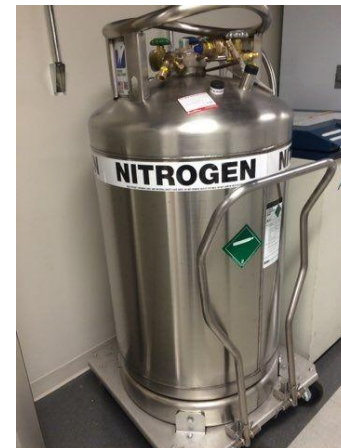
In February 2018, a Yale researcher contacted EHS because they were unable to close the valve on one of the liquid nitrogen dewars in the laboratory. The personal oxygen monitor in the lab indicated that oxygen levels were lower than normal. Upon arrival, EHS found that the researcher was able to shut the valve, however the oxygen levels at the entryway to the laboratory were 18 percent, indicating an oxygen deficient atmosphere. With the dewar valve closed, the oxygen levels quickly rose back to normal.

- The supplier was contacted. They removed the tank with the faulty valve and replaced it with a new one.
- The research group was reminded of the proper procedures to take if this type of valve failure occurred again, including immediate replacement of the dewar and evacuation of the laboratory when the oxygen monitor alarms.

- Ensure all valves are working properly.
- Report problems immediately to the lab manager or PI.
- Contact the supplier as soon as an issue is noted to prevent catastrophic failures.
- In laboratories where large amounts of cryogen are used/stored, a personal or fixed oxygen monitor may be necessary. Contact your Safety Advisor for an evaluation.
